CLAYTON

Elementary School

Certificate of Necessity

Project No.: 18047
August 09, 2019

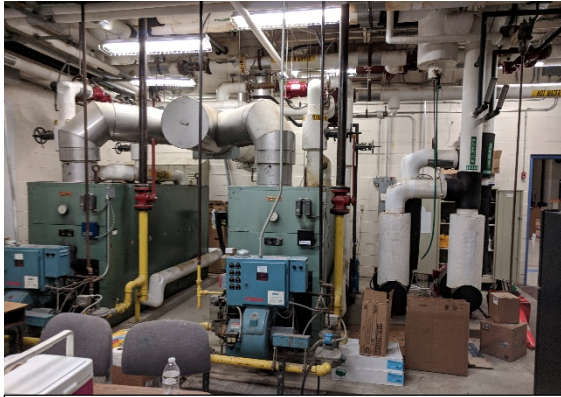
- The central heating plant is past its useful service life and overdue for replacement. (Photograph #1)
- The exhaust/make-up air ventilation unit serving the kitchen is past its useful service life and should be replaced with a new system. (Photograph #2)
- All (8) rooftop exhaust fans are past their useful life and should be replaced. (Photograph #3)
- Classrooms 1 – 15 in the original building have comfort and humidity issues that need to be addressed in a study. It is likely that the UVs (15 total) are not properly controlling the outside air damper and will need to be upgraded. (Photograph #4)
- The air cooled chiller has aged past its recommended service life and is due for replacement.

Photograph #1 – Boilers in Mechanical Room

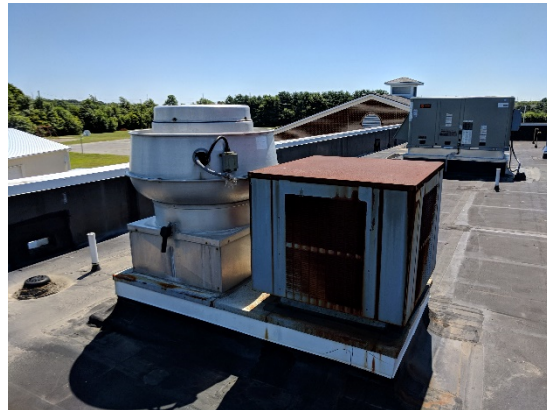
Photograph #2 – Kitchen Ventilation Unit

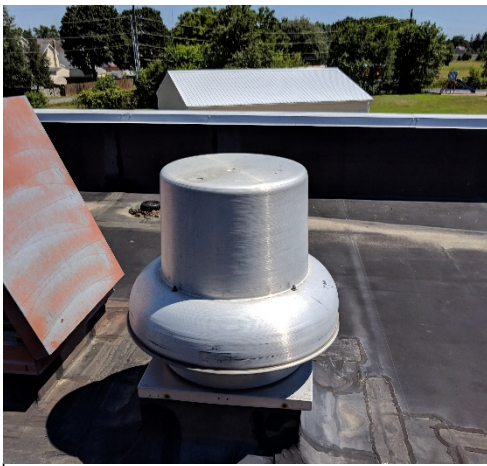
Photograph #3 – Typical Exhaust Fan

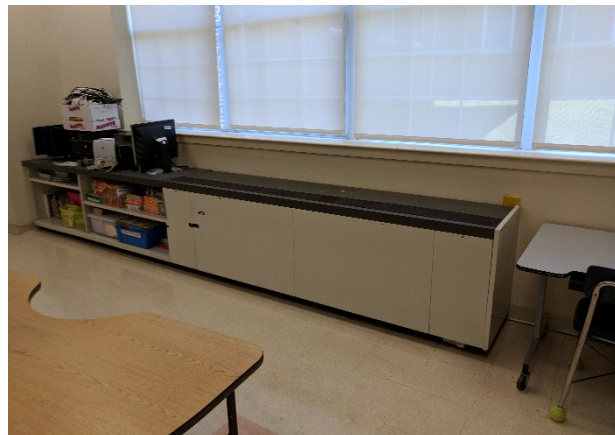
Photograph #4 – Typical Classroom Unit Ventilator

Some, if not all of these issues have been documented at CES.

However, since there is already a central chiller in place with useful remaining service life, it is unrealistic to recommend a complete system replacement. The best compromise is to modify existing UV controls to only provide space cooling (no ventilation) with economizer function. New Energy Recovery Units (ERU) would be installed on the roof or in mechanical mezzanines. This system modification maximizes

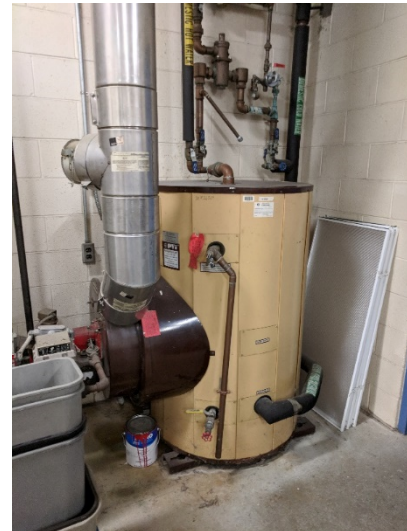
Photograph #5 – Water Heater

- Replace the domestic hot water heater and recirculation pump (Photograph #5)

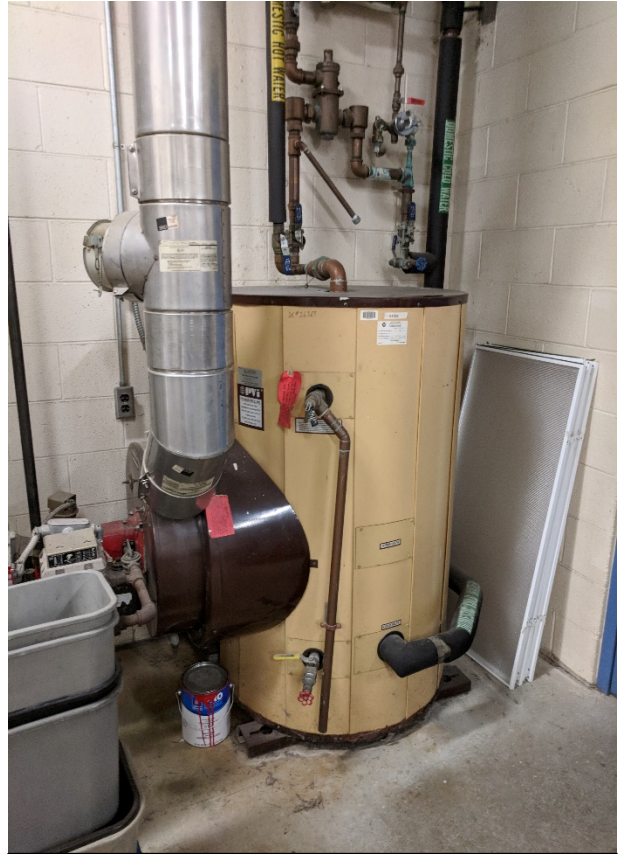
Photo #6 Domestic Hot water Heater in Mechanical Room

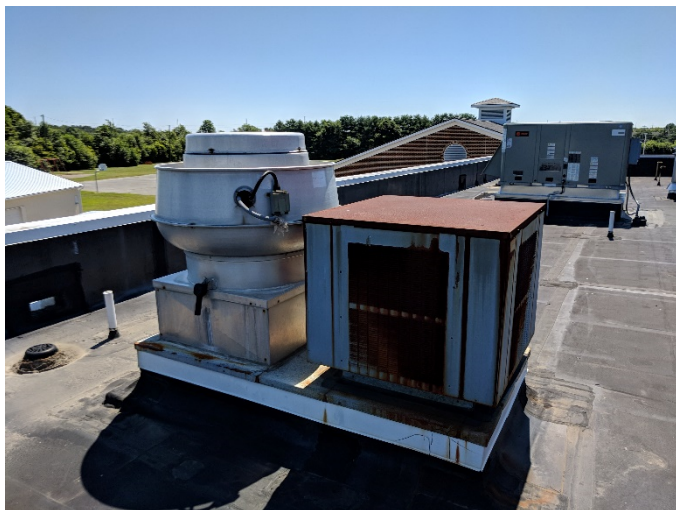
Photo #10 Kitchen Ventilation System

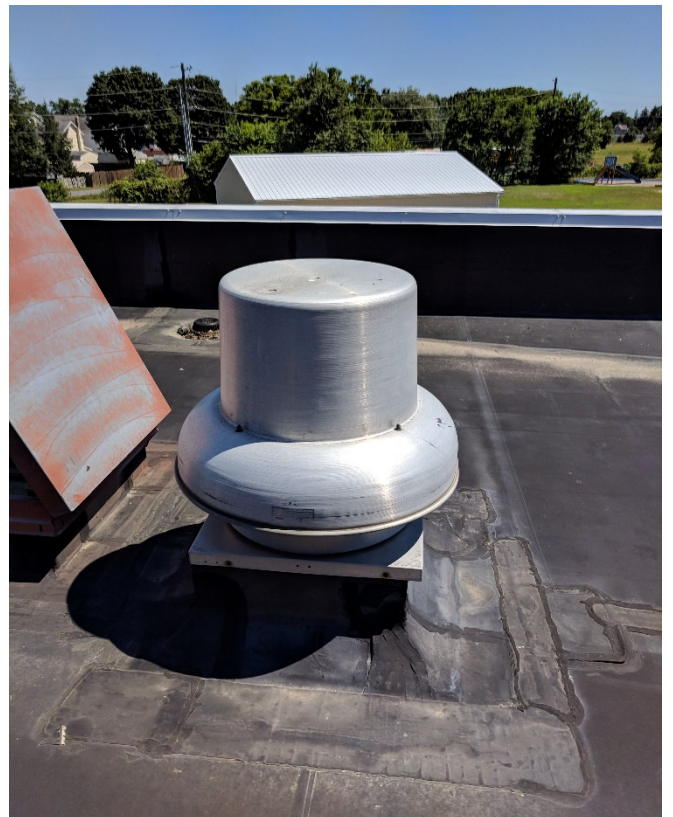
Photo #11 Typical Roof Mounted Exhaust Fan

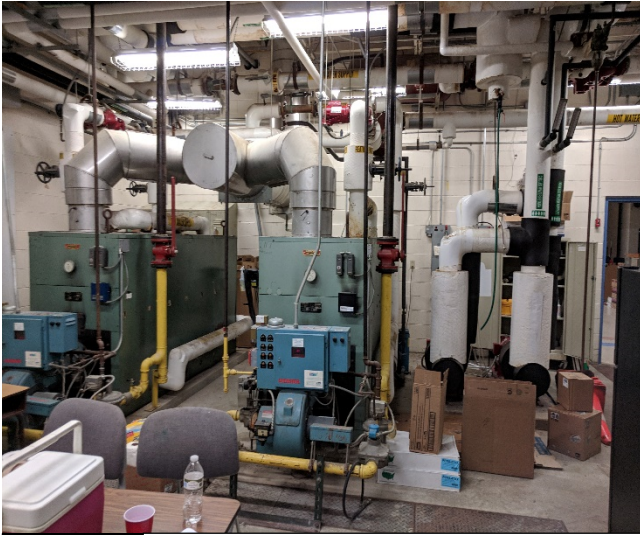
Photo # 12 Boilers in Mechanical Room

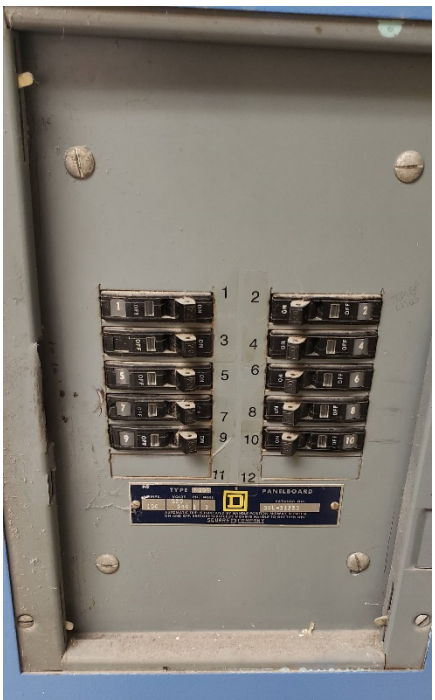
While the existing system has been well maintained and the panelboards are currently working, there are a few panelboards that have exceeded their useful service life. Panelboards labeled as LP-A, LP-B, and MDA-2 have all exceeded their useful service and we would recommend that the same be replaced. The switchboard SE and panelboards LP and CP were installed in 2006 and panelboards CP-1 and CP-2 were installed in 2009. Distribution Panelboard MDP and most of the other branch panelboards throughout the school are manufactured by GE and were installed in 1993.

Photo #4 Panelboard LPB

- Replace panelboards MDA-2, LP-A, LP-B.

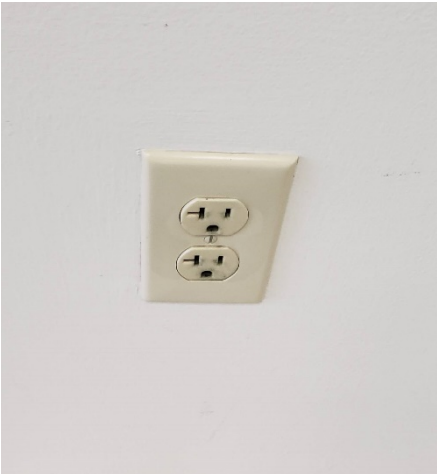
While the building appears to be in good condition, the recessed receptacles installed in the building are beginning to show signs of aging. Over the years, additional receptacles have been installed using surface metal raceway. The current National Electrical Code (NEC) requires that all child care facilities have tamper resistant receptacles. The code defines a child care facility as a building or portion thereof, for educational, supervisory, or personal care services for more than four children 7 years old or less. So, this elementary school would fit this definition so we would recommend that all non-locking-type 125V, 15 and 20 ampere(A) existing receptacles be replaced with tamper-resistant receptacles. Some of the exterior disconnects are beginning to show signs of rusting, so we would recommend that new NEMA 4X, stainless steel disconnects be provided for all exterior HVAC equipment that is replaced. The technology department has some planned improvements for buildings special systems as outlined below in the planned improvements section of this report.

Photo #10 Typical Receptacle

1. Replace all existing building non-locking-type 125V, 15 and 20 ampere receptacles with tamper-resistant receptacles to comply with the current National Electrical Code.
2. Upgrade Fire Alarm system to voice evacuation system to comply with current NFPA 101 Life Safety Code.
